AVIONS PIERRE ROBIN

SERVICE BULLETIN N° : 51

OBJECT : Modification of blanking plates, on rear fuselage sides.

AIRCRAFT CONCERNED : HR 200/100 and HR 200/120, up to n° 26 inclusive,  
except n° : 20, 23, 24 and 25.

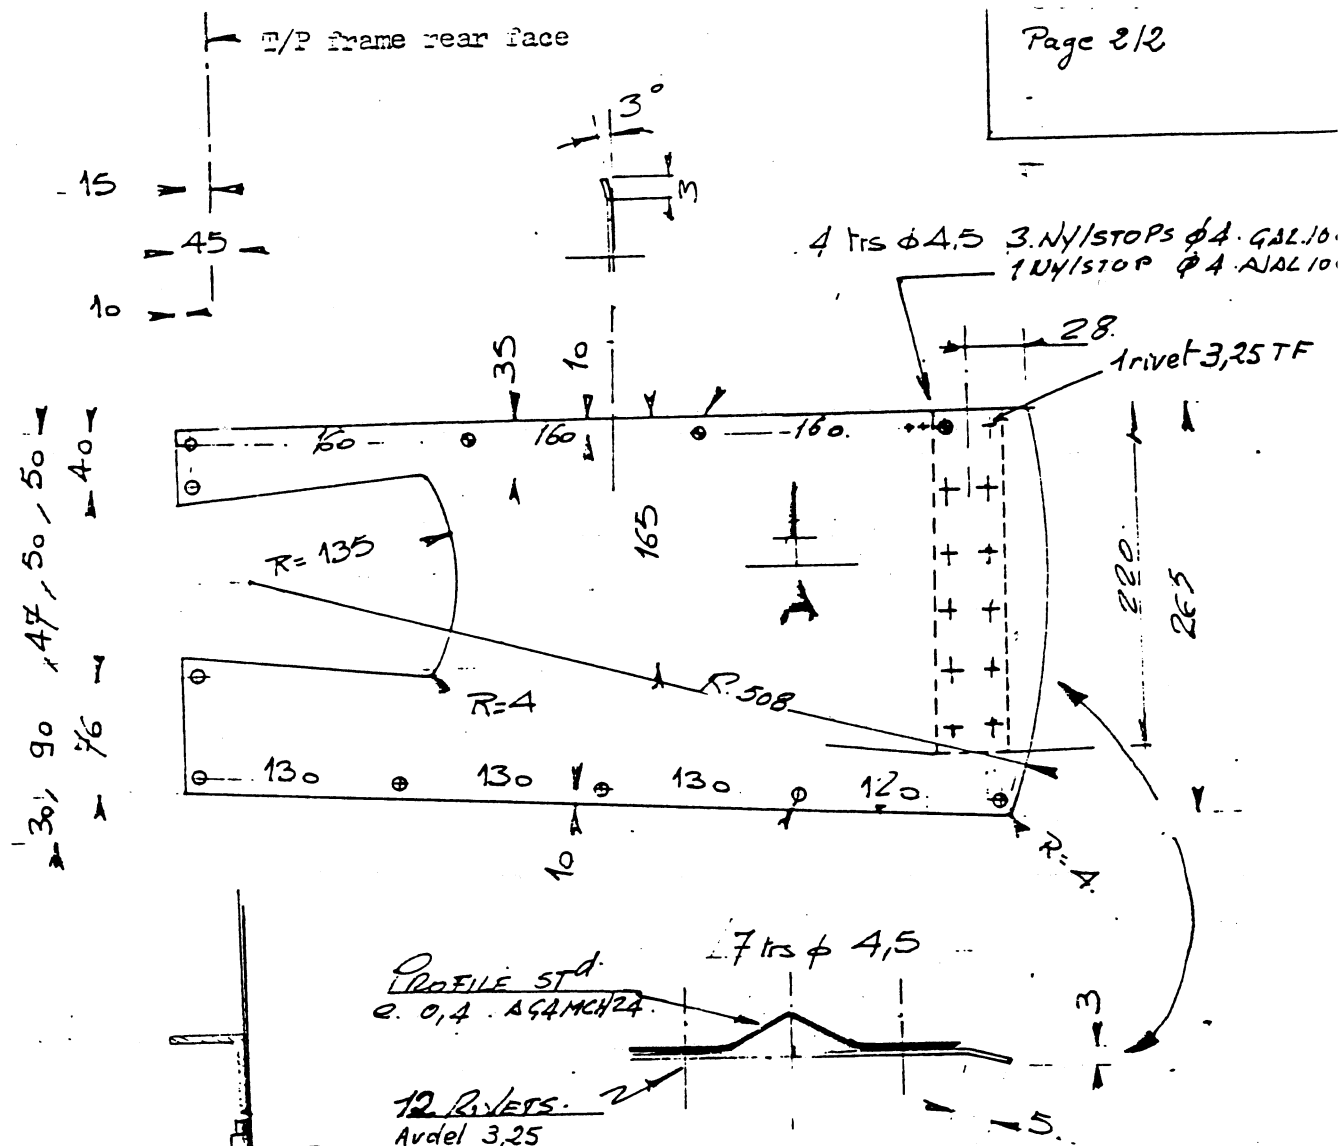
Upon receipt of this Service Bulletin, check to see if the fork-end fitting of the elevator tab control comes into contact with the end of the rear fuselage blanking plate, or if the said end of the plate is distorted. If this is the case, embody Modification n° 1166 (see drawing, page 2/2) as soon as possible. A ferrying flight can be carried out, after having straightened the plate rear end so as to prevent it from contacting the fork-end fitting.

In any case, Modification n° 1166 (which consists in rivetting a stiffener on the inside face of the plate, and in reducing the length of the latter) must be embodied, at the latest, within the next 20 flying hours and, in any case, before June 30th 1974.
