OBJECT : Replacement of n°1 flap rib assembly.

AIRCRAFT CONCERNED : All HR 200 types, up to Serial n° 68 inclusive.

DATE : 18-04-1975

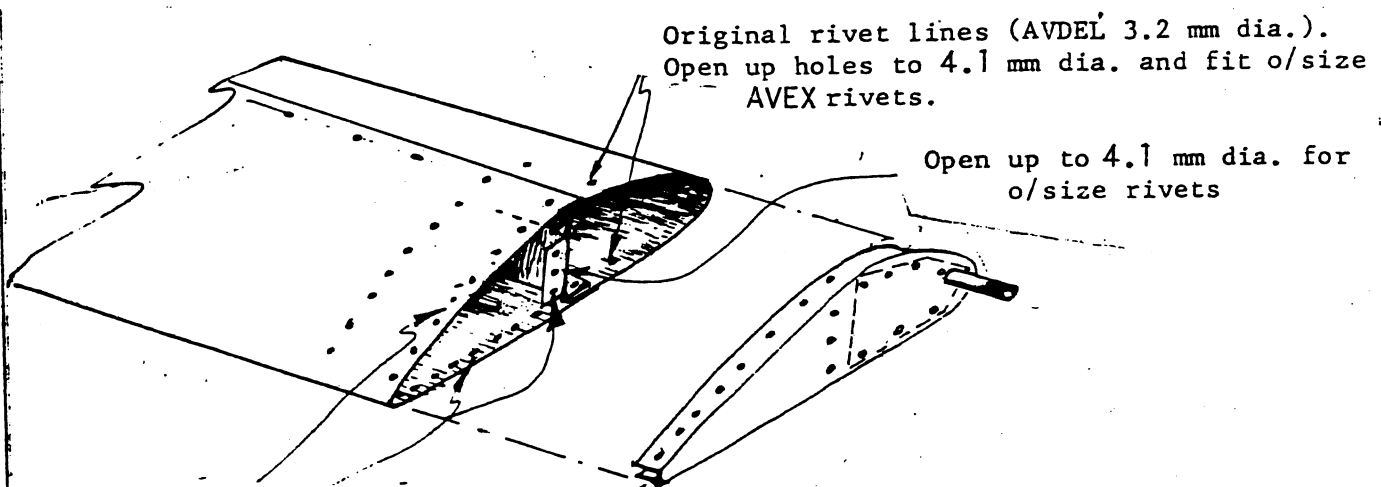
Since the previously fitted part is not entirely satisfactory, fatigue-wise, it is recommended that you should replace the n°1 rub assembly fitted to each flap of your aircraft. It is the rib nearest to the fuselage, supporting the flap lowering control shaft.

- 1 - Rivets to be drilled out
- 2 - Rib assy. to be changed
- 3 - Position new rib assy. and secure in position with the o/size rivets supplied with the kit.

- 10 - Place the new rib in position
- 11 - Open up the rivet holes to 4.1 mm dia.
- 12 - Rivet the new rib assembly with the AVDEL oversized rivets supplied with the kit
- 13 - Refit the flap in position
- 14 - Carry out the same operations, on the second flap
- 15 - Check flap deflection angles (see Flight Manual, page 1.2). If necessary, adjust by means of the swivelling rod (adjust its length)
