**AVIONS PIERRE ROBIN**

**BULLETIN DE SERVICE**  
**SERVICE BULLETIN**

**N° 75**

**Objet** Object: Replacement of 3-rib flaps

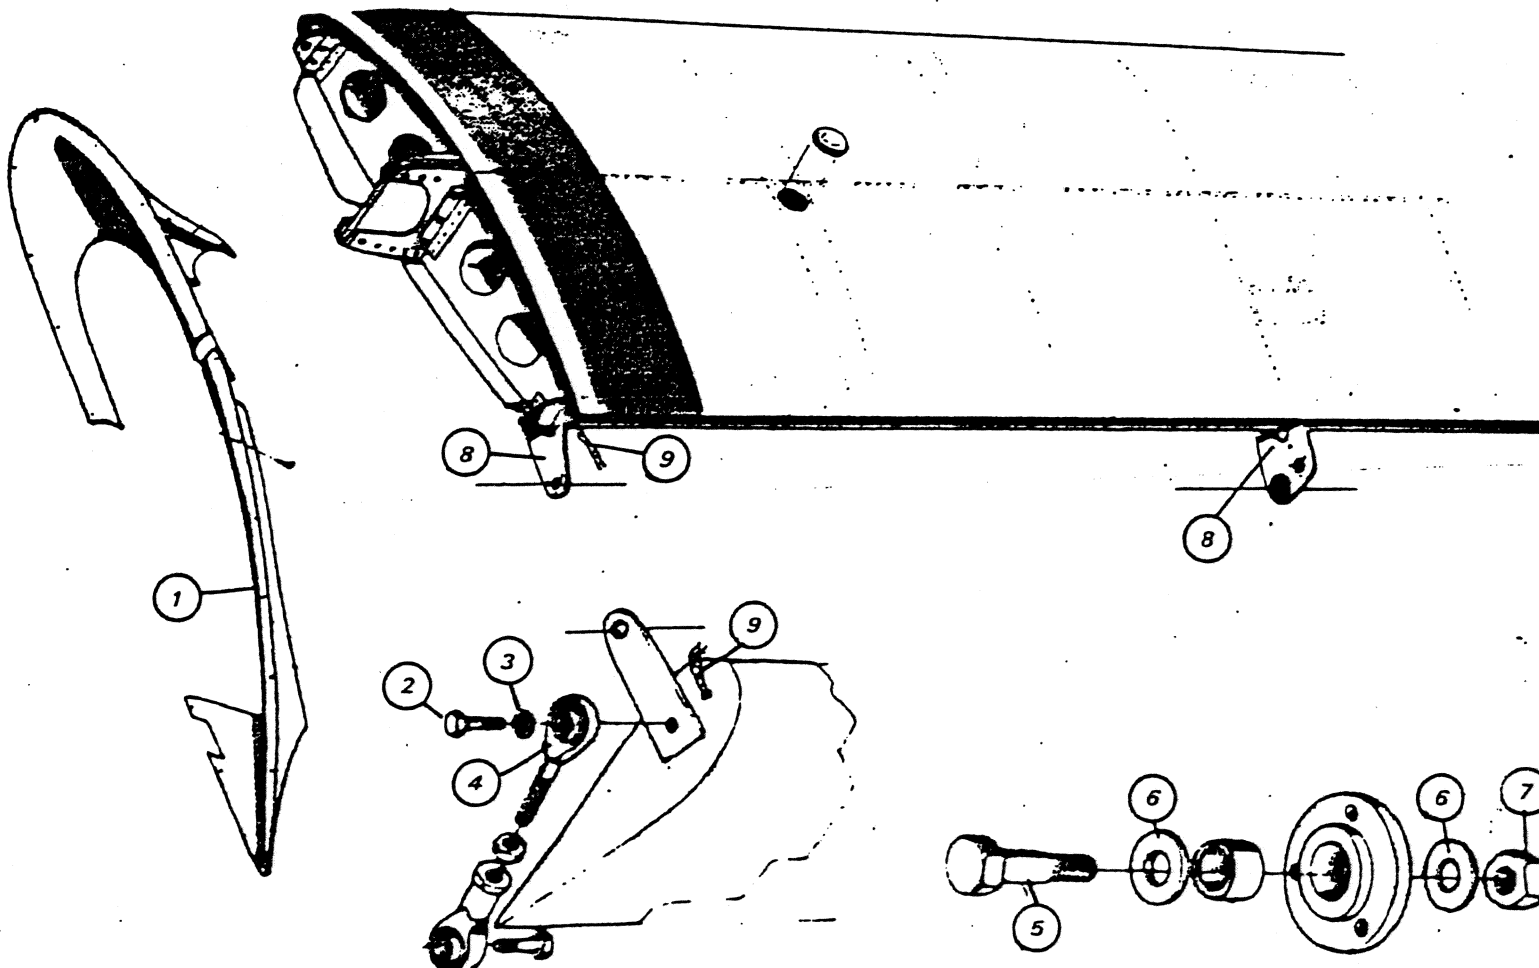
- 1 Remove the rear section (1) of the wing root fairing.
- 2 Using the electrical control, lower the flaps fully. Remove the screw (2) and the washer (3) securing the rod end (4) to the flap.
- 3 Remove the bolts (5), washers (6) and nuts (7) securing the flap to its brackets (8).
- 4 Disconnect one end of the bonding braid (9)

- 1 Offer up the flap in position and fit the securing bolts (5), making sure that washers (6) are correctly located. Fit and tighten the nuts (7).
- 2 Connect the free end of the bonding braid (9) with the appropriate screw.
- 3 Fit the screw (2) and washer (3) securing the rod end to the flap.
- 4 Fit the rear section (1) of the wing root fairing.
- 5 Check the angular deflection of the flaps (see Flight Manual, page 1.3). If necessary, adjust the length of the ball-and-socket rod, to obtain the correct deflection.
