AVIONS PIERRE ROBIN

BULLETIN DE SERVICE
SERVICE BULLETIN

N° 90

Reinforcement of aileron/flap common support bracket
R 2000 all types, all Serial numbers.

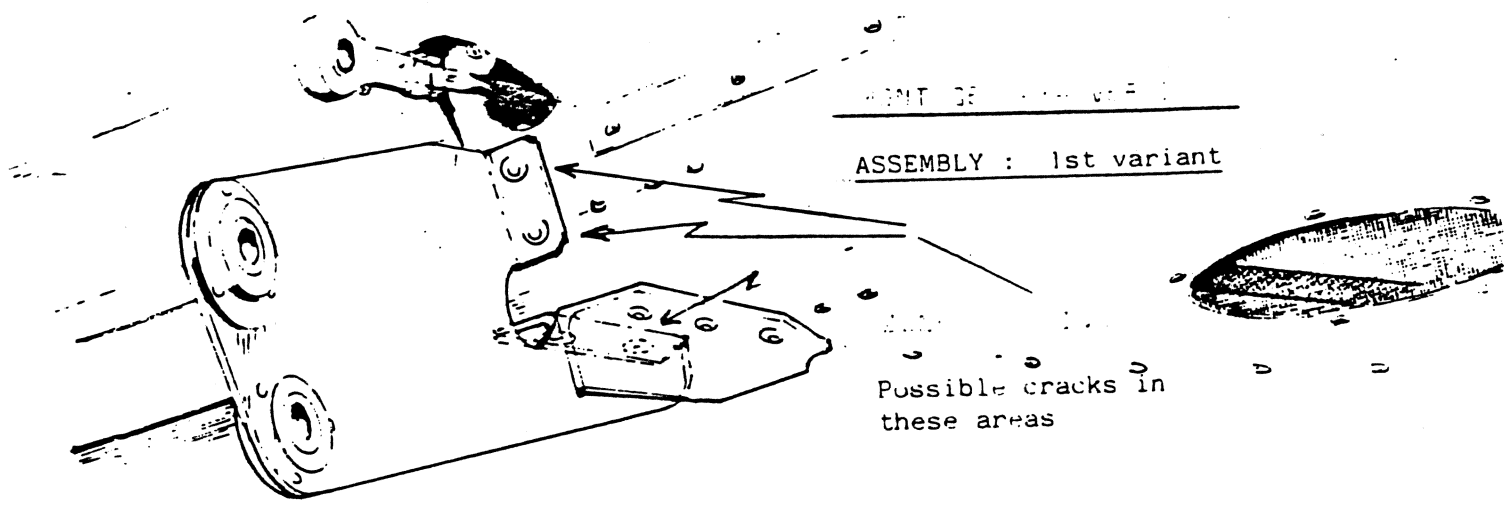
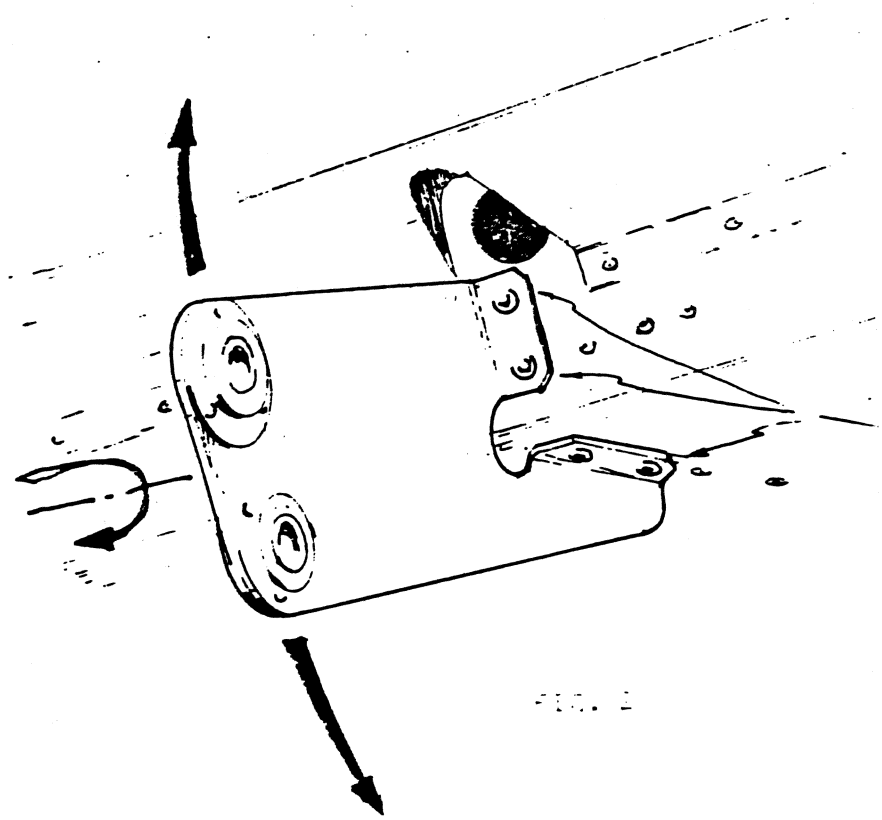
FIG. 1

Cracks have been detected close to the attachment points of the RH and LH aileron/flap common support bracket and corresponding wing skin areas.

Within the next 50 flying hours following the receipt of this S.B. check the soundness of this attachment. To this end, manually apply an up-down load accompanied by a torsion load, as shown on figs. 1 and 2, to find the presence of possible cracks, loose rivets and/or separation of the bracket from the skin.

POINT OF ATTACHMENT

ASSEMBLY : 2nd variant

Folded metal sheet, without angle section

Possible cracks in these areas

- 1 If a defect is detected, embody the applicable A.P.R. modification (aileron/flap support bracket repair kit) before further flying.
- 2 If no defect is detected, renew the checks every 50 flying hours, until the aileron/flap support bracket is repaired. The repair kit must be fitted, at the latest, at the next Major Inspection.

Repair must be carried out in an approved workshop.
