AVIONS PIERRE ROBIN

BULLETIN DE SERVICE  
SERVICE BULLETIN

N° 97

Objet Object : ENGINE BEARER

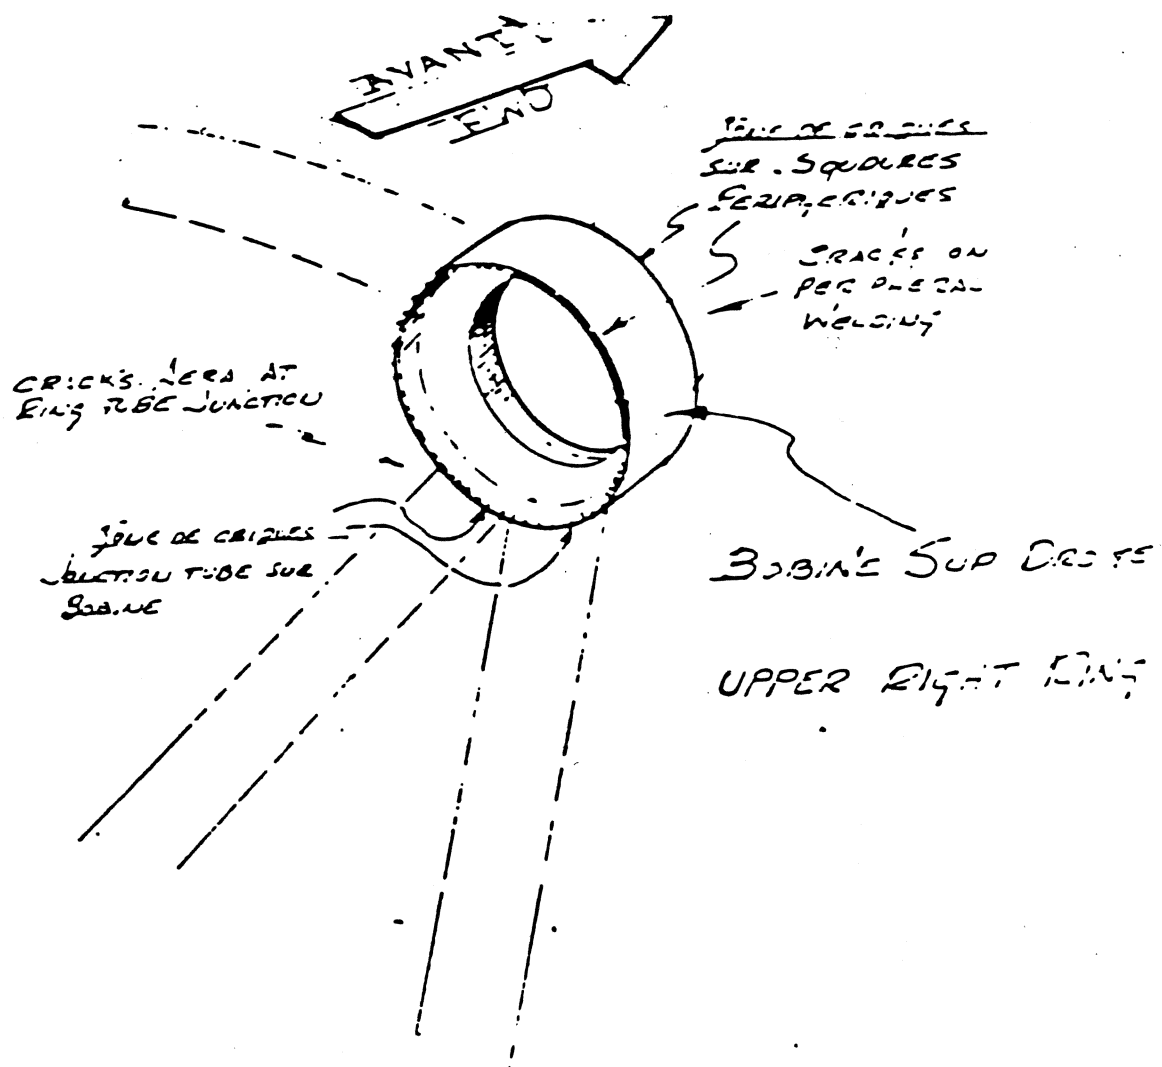
Cracks have been found close to the spools of the engine bearer (see figure attached). Please check as follows :

Upon receipt of this S.B., carry out a detailed visual inspection of the engine bearer, where the damping mount supports (spools) are welded to the frame.

If no cracking is found, repeat this inspection at least every 25 flying hours.

If a crack is found, the aircraft must be grounded until the defective engine bearer is replaced by a reinforced engine bearer supplied by the constructor (ref. 51.40.30).

The fitting of a reinforced engine bearer cancels the above specific inspection procedure, the engine bearer being inspected as laid down in the normal servicing Inspection procedure.

Whatever might be the results of the above specific inspection, a reinforced engine bearer must be fitted, at the latest, during the next Major Inspection.
