AVIONS PIERRE ROBIN

LETTRE DE SERVICE
SERVICE LETTER

N° 22

Objet Object : Air filter attachement.

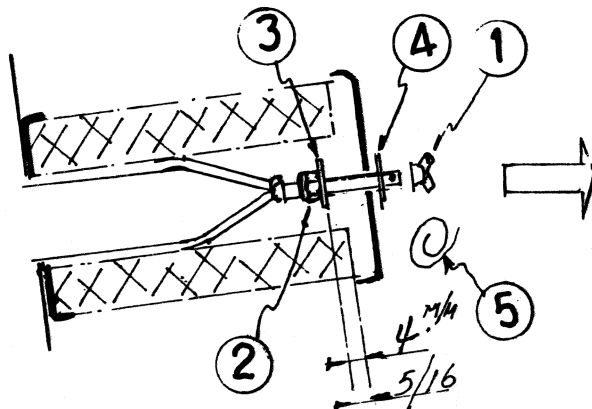
At Service Inspections, same cases of damage to the air filter have been detected. In order to improve the attachement, proceed as follows at your next air filter exchange (50h. visit).

1° On the central attachement rod, put a self-locking nut \emptyset 5 mm, NYLSTOP or SIMLOCK (see figure item 2) with the locking device on the engine side.

2° Place a washer, type L, cadmium plated steel, item 3, which will support the filter cap. This washer has to be positionned 4 mm, $5/16$ " below the uncompressed filter (see figure).

3° Put the filter cap, then a washer (type C, cadmium plated steel, \emptyset 5 mm, item 4).

4° Tighten in order to have a correct seizing and lockwiring the nut with appropriate stainless steel wire \emptyset 6 /10 mm, item 5.
