# SERVICE BULLETIN

**AA-SB-27-003**

## Rudder Bar – Inspection & Replacement

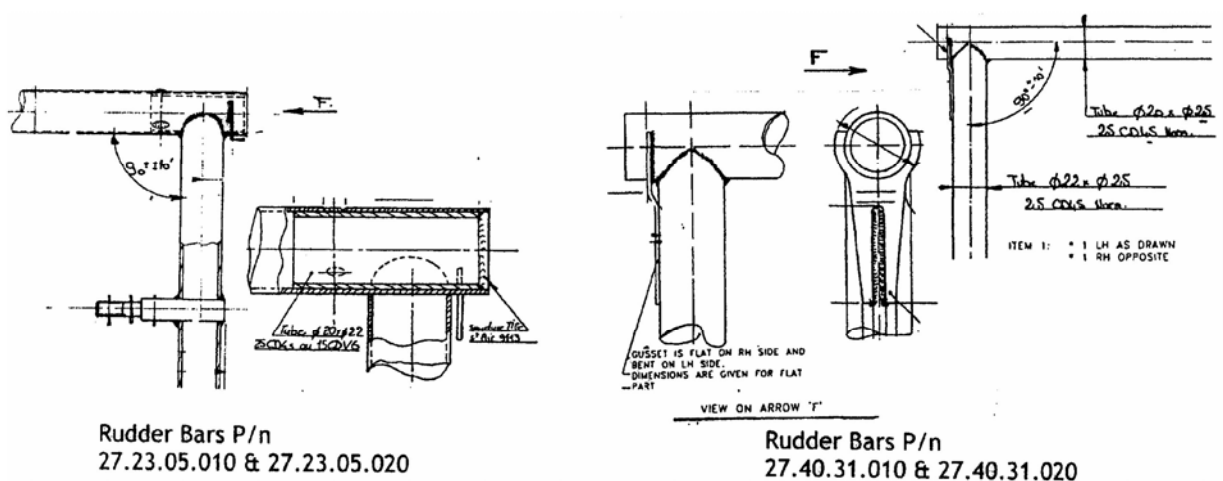
**Figure 1**

Replace rudder bars P/N 27.23.05.010 and 27.23.05.020 (LH & RH) with rudder bars P/N 27.40.31.010 & 27.40.31.020 (LH & RH) in accordance with the compliance instructions in 1.5. To aid identification of the different part number rudder bars refer to Fig 1.

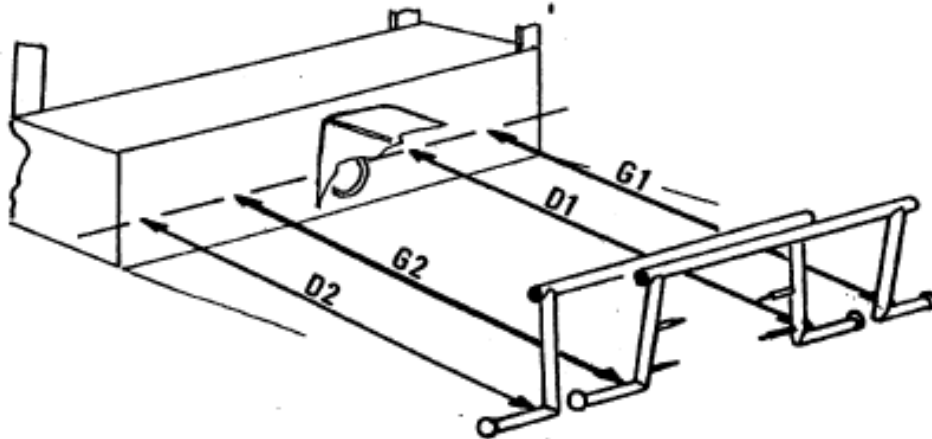
**Figure 2**

Model R2100, R2100A, R2112, R2160, R2160D and R2160i aircraft: Replacement is required.  
Model R2120U and HR200 Series: Replacement is recommended. Measure the rudder bars for distortion in accordance with Fig 2. If distortion is equal to or greater than 10mm then replace both rudder bars.

Maintain the rudder bars in the neutral position and measure distances G1, G2 and D1, D2. The difference between G1 and G2, or D1 and D2 is the distortion.

1. If  $D1 = D2$  and  $G1 = G2$  ( $\pm 5$  mm), there is no significant distortion and no action is required, re-inspect at intervals not to exceed 500 hrs TIS.
2. If the distortion is between 5 and 10 mm re-inspect at intervals not exceeding 100 hrs, until replaced by P/N 27.40.31.010 and P/N 27.40.31.020.
3. If the distortion is equal to or greater than 10 mm, replace both rudder bars
