SERVICE BULLETIN

AA-SB-53-001

Harness Attach Bracket – Installation of fuel tank chafing protection

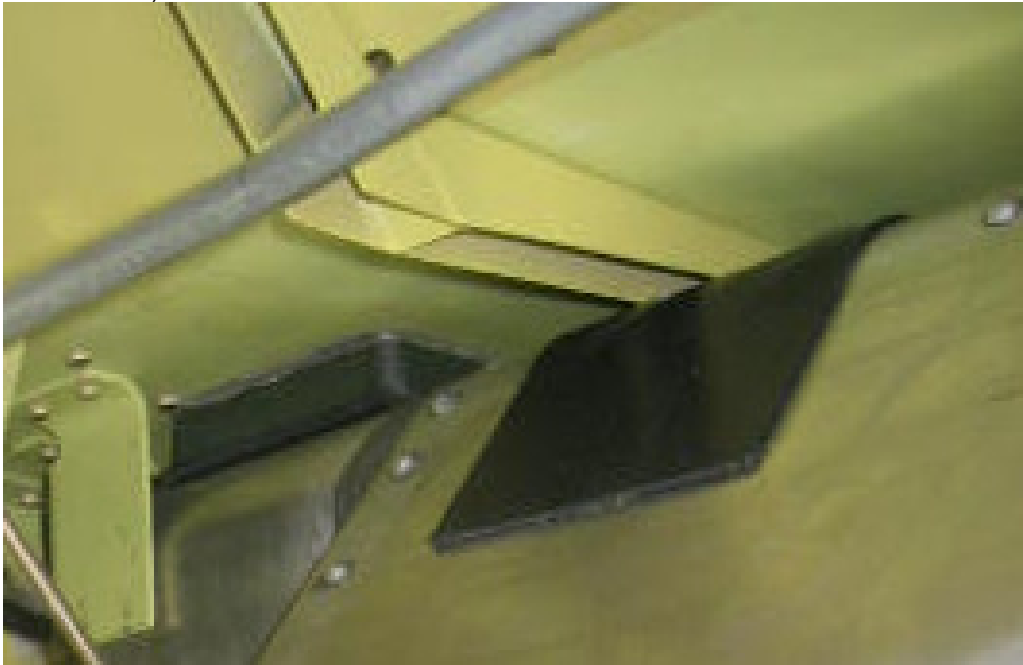
Figure 1.4: Harness bracket, rubber pad and fuel tank.

A maintenance organization has reported an instance where seat belt attach brackets P/N 60-53-025-001 cut through the protective rubber and contacted the fuel tank. This could possibly chafe through the fuel tank skin.

The bracket attaching the harness to the fuselage behind the seats is installed between the baggage shelf and the fuel tank. Due to the close proximity of the fuel tank to the bracket, a rubber pad was installed to protect the fuel tank. The fuel tank has other retaining mechanisms preventing contact pressure between the fuel tank and the harness attach bracket. However, it appears in some individual cases the tank and bracket makes contact with sufficient pressure to cut through the rubber over a period of time. (See Figure 1.4 showing the harness bracket, rubber pad and fuel tank.)

- If no sign of contact is detected and the gap between the fuel tank and harness attach bracket is positive, no further action is required, and the aircraft can be returned to service.
- If contact between the fuel tank and harness bracket is detected: Fabricate and install an anti chafing U-channel described in §2.0.
