# SERVICE BULLETIN

**AA-SB-71-004**

## Engine Mount Inspection and Repair

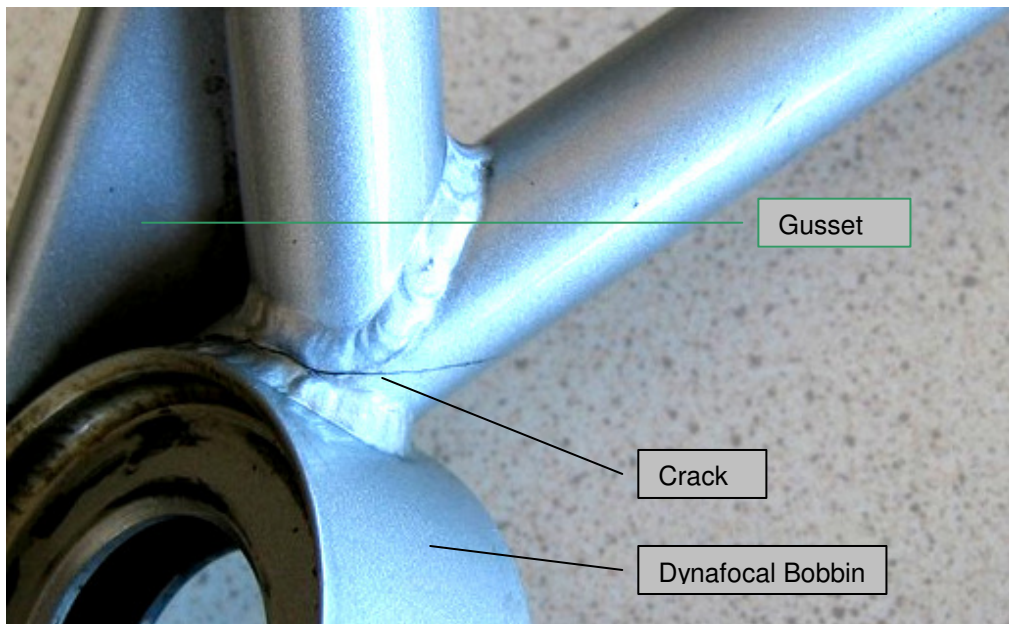
Cracks have been reported in the tubes near the RH upper engine mount bobbin. (See Figure 1).

Within the next 10 flying hours, carry out a thorough visual inspection of the engine mount frame tubes near the welds. In the reported cases cracks were found in the tubes near the RH upper Dynafocal mount.

**Figure 1: Cracked engine Mount Tube**

- Prepare any cracked area by filing a V-groove along the crack and weld-repair crack using AMS6458 filler wire. (Weld Filler Wire can be obtained from Alpha Aviation.) Remove the gusset to obtain access to the crack if required.

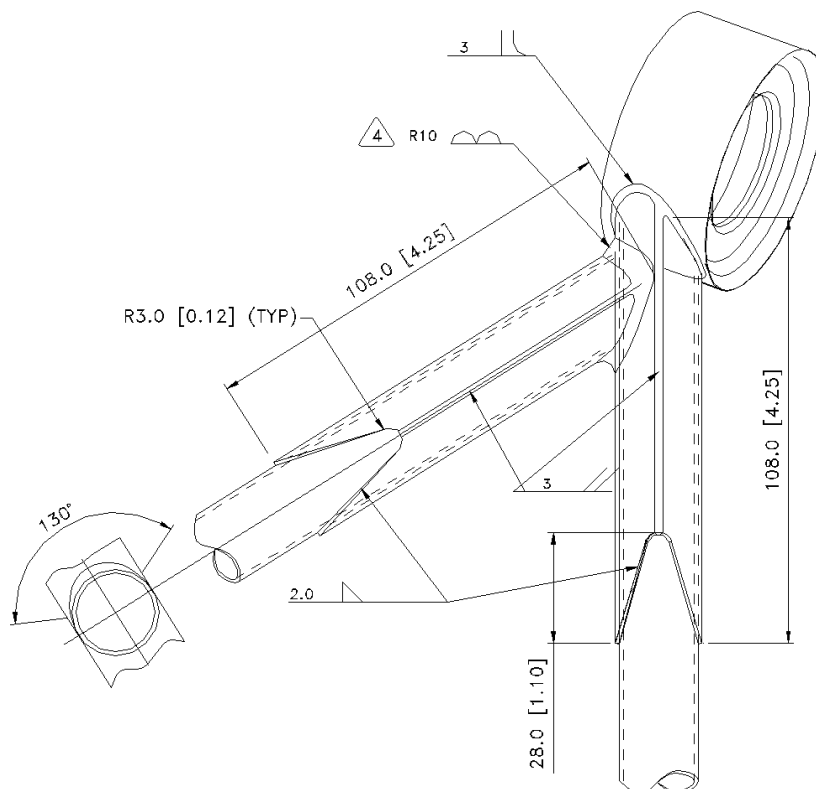
**Figure 2.1: Outer Split Sleeve Repair welded over cracked area.**

- Magnetic Particle Crack Check Repaired Crack Area to ASTM E 1444-05.
- Fabricate reinforcing split sleeve doublers from 25CD4S OR AISI 4130 steel tube with Internal Diameter of 20mm, and 1mm (0.040") to 1.6mm (0.063") thick, for each of the four Dynafocal bobbin positions. Fabricate the doubler shapes to coordinate with mating tubes and bobbins. Weld the reinforcing doublers in place over any repaired cracks as shown in figure 2.1, figure 2.2 and drawing 97-71-041 making use of AMS6457 of AMS6458 filler wire.

- Form R10 fillets over the 130° nearest to the bobbin, by means of multiple weld runs. See note 4 in figure 2.1 below or note 5 on drawing 97-71-041. Blend out any irregularities and pitting to a smooth finish. All welds near the bobbin must be blended and free from pitting.
- Re-weld the gusset in place. Fabricate a new gusset to replace the original removed gusset from AISI 4130 Steel Sheet, 1.6mm (0.063") thick if the original gusset is not re-usable.
- Flame Normalise the weld heat affected area in accordance with drawing note 8.
- Magnetic Particle Crack Check Assembly to ASTM E 1444-05.
- Repaint the engine frame, using a good quality 2K paint to match the existing paint on the engine frame.
- Treat tubes internally using boiled linseed oil and plug holes with AD42 rivets.
- Re-install in accordance with the Alpha R2000 series or applicable Service Manual.

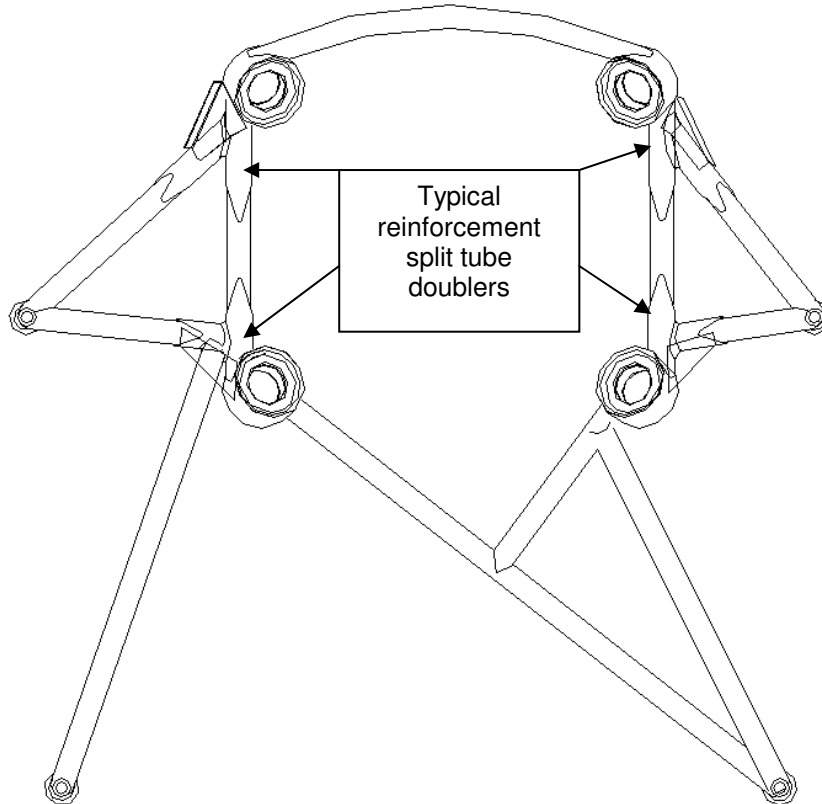
**Figure 2.2: Typical reinforcement locations. Note that any straight tube to bobbin joints may be repaired in accordance with this service bulletin and drawing 97-71-041.**
