SERVICE LETTER

AA-SL-78-001

Exhaust System

HR200 and R2000 Series aircraft fitted with 2 into 1 exhaust system.

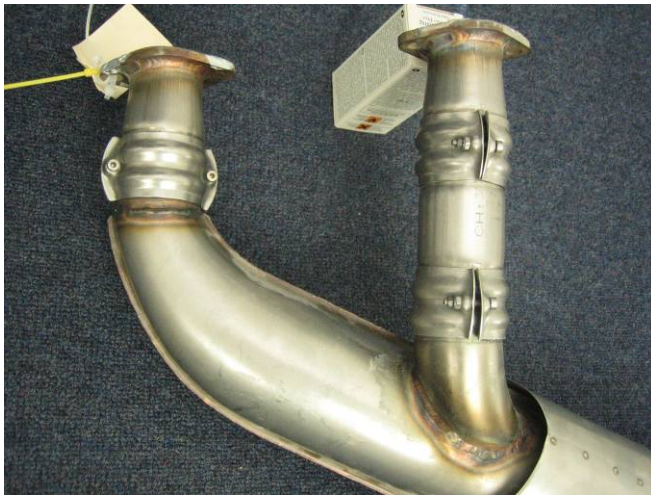
Fig 1

In October 1990, Avions Pierre Robin issued Service Letter 35 advising owners of the need to ensure the ball joints on 2 into 1 exhaust systems (see Fig 1) are set up correctly.

We are aware of at least one instance where this instruction was not followed and resulted in the exhaust system cracking. This can allow exhaust products to enter the cabin heating system.

It is recommended that the ball joints are inspected in accordance with the instruction in the original Service Letter to ensure lateral movement is present.
