# SERVICE BULLETIN

**AA-SB-27-004**

## **Stabilator Hinges – Inspection & Re-torque**

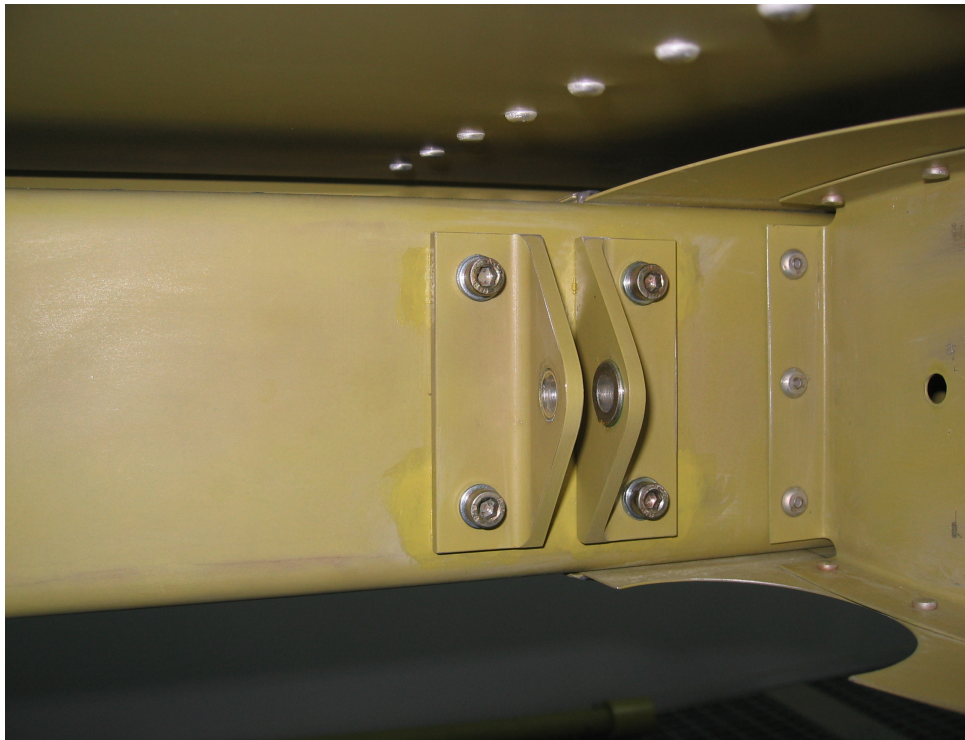
**Figure 1: Typical Stabilator Hinge Installation**

A maintenance organization has reported an instance where a stabilator hinge bracket P/N 32-23-08-000 was found to be loose and the torque on the attaching bolts to be low. The cause for the low torque appears to have been due to the heads of anchor nut rivets sitting proud of the spar face which caused fretting and a reduction in clamping forces.

Inspection:- Remove L & RH access panels (Service Manual Fig 2-3 item 8) Inspect the stabilator hinge brackets for signs of movement. See fig 1 below for installation of the stabilator hinges. Check the torque on the bracket attaching bolts (the minimum torque is 44 inlb). If there are signs of movement or the torque is below the required figure then the brackets must be removed to identify if anchor nut attaching rivets are proud of the spar face. Prior to removing the bracket, it may be advisable to mark its position to facilitate re-installation in the same position.

Slacken stabilator control cables in accordance with Service Manual section 5.6. Place padded support under stabilator and on top of horizontal bulkhead then remove stabilator hinge bolts and lower stabilator onto pad. Note it may be necessary to disconnect the anti-servo tab linkage to gain full access, see Service Manual section 5.7.

Examine rivet heads, spot face any protruding rivet head. Examine rear face of hinge bracket for wear caused by rivet heads. Apply primer to bare metal surfaces. Reassemble in accordance with Service Manual section 4.4.3 (Temporary revision 4/4/001 Issued 14 March 2008), and torque to 44 inlb. Reinstall stabilator and tension control cables in accordance with Service Manual section 5.6.2.2 and 5.6.3.
