AVIONS PIERRE ROBIN

SERVICE BULLETIN N° : 51

OBJECT : Modification of blanking plates, on rear fuselage sides.

AIRCRAFT CONCERNED : HR 200/100 and HR 200/120, up to n° 26 inclusive,  
except n° : 20, 23, 24 and 25.

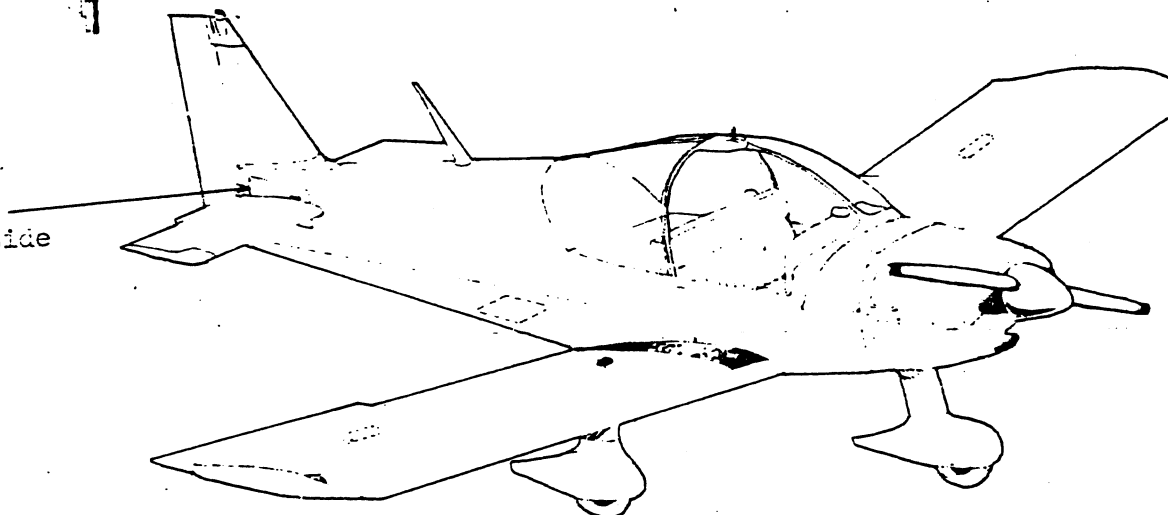
Upon receipt of this Service Bulletin, check to see if the fork-end fitting of the elevator tab control comes into contact with the end of the rear fuselage blanking plate, or if the said end of the plate is distorted. If this is the case, embody Modification n° 1166 (see drawing, page 2/2) as soon as possible. A ferrying flight can be carried out, after having straightened the plate rear end so as to prevent it from contacting the fork-end fitting.

Blanking plate

Rear fuselage side

In any case, Modification n° 1166 (which consists in rivetting a stiffener on the inside face of the plate, and in reducing the length of the latter) must be embodied, at the latest, within the next 20 flying hours and, in any case, before June 30th 1974.
