SERVICE BULLETIN

AA-SB-28-004

Replacement Fuel Cap

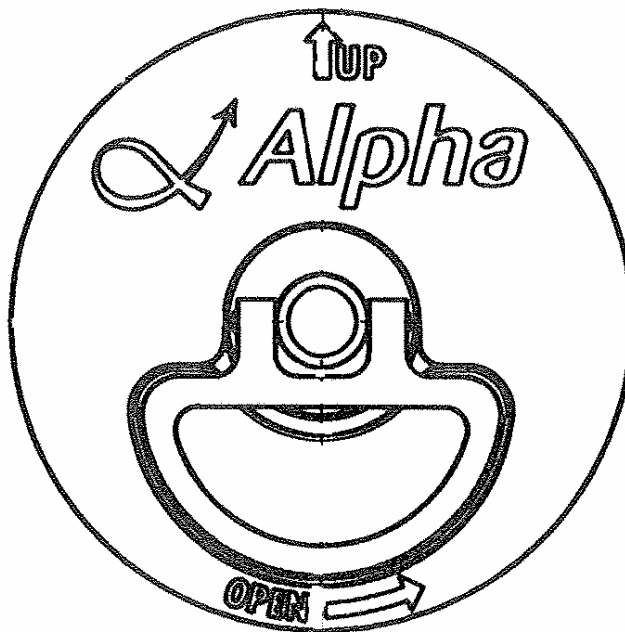
- Lift the D-ring and rotate 90 degrees in the direction of the arrow "OPEN".
- Place in the filler neck.
- Turn the D-ring back 90 degrees against the OPEN arrow.
- Push the D-ring all the way down to lock in place.

Remove existing Fuel Cap from aircraft. Install replacement Fuel Cap P/N 60-28-053-001 in place of the existing fuel cap.
